# ELECTRICAL OVERSTRESS TEST PROGRAM AND INTEGRATED CIRCUIT FAILURE MODE EVALUATION

The BDM Corporation  
P.O. Box 9274  
Albuquerque International  
Albuquerque, New Mexico 87119

26 April 1978

Final Report for Period May 1977—October 1977

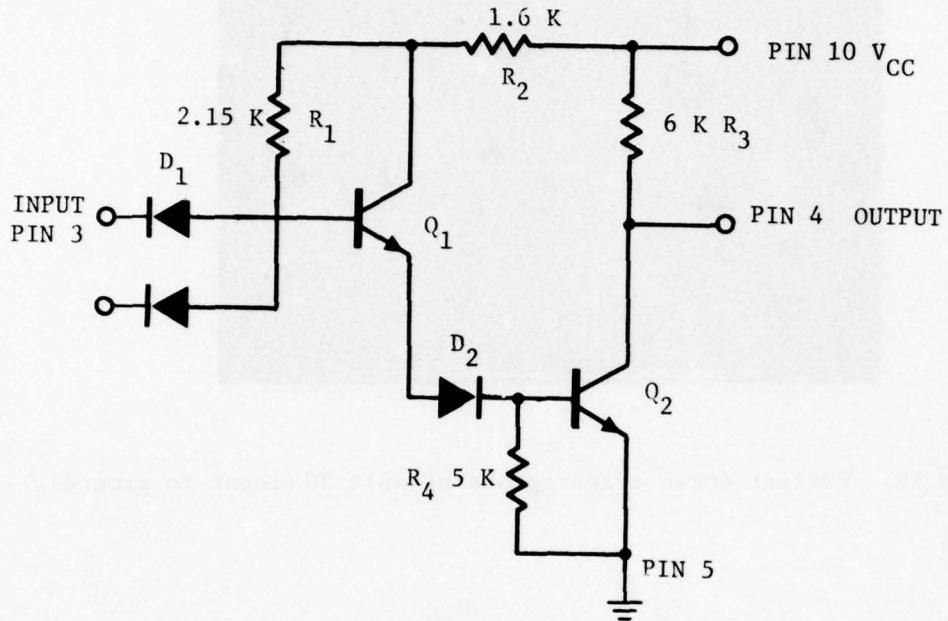
Figure 18. Circuit schematic of one 946 HC NAND gate.

The 946 HC device illustrates this type of failure. Figure 18 is a circuit diagram for one of the four two-input NAND gates that constitute the 946 HC. In the positive input stressed condition the current passes through the reversed biased input diode and then through three forward biased junctions. For the negative stressed input, the current path is through the forward biased diode; resistors  $R_1$ ,  $R_2$ , and  $R_3$ ; the forward biased collector-base junction of  $Q_2$ ; and resistor  $R_4$ . The curve tracer photo of Figure 19 illustrates these current paths from pin 3 to ground in the positive and negative directions. As shown in Figure 19, the breakdown voltage of the input diode is about 6 volts. Figure 20 is a photomicrograph of the 946HC chip.

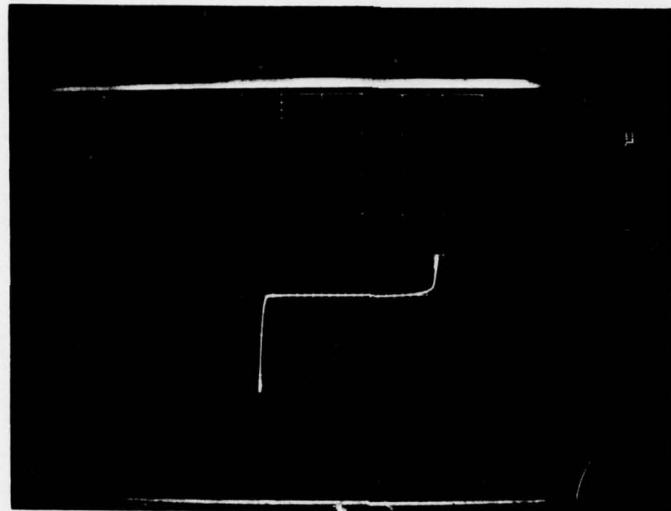
Figure 19. Pretest curve tracer photo of unit 50 (input to ground).

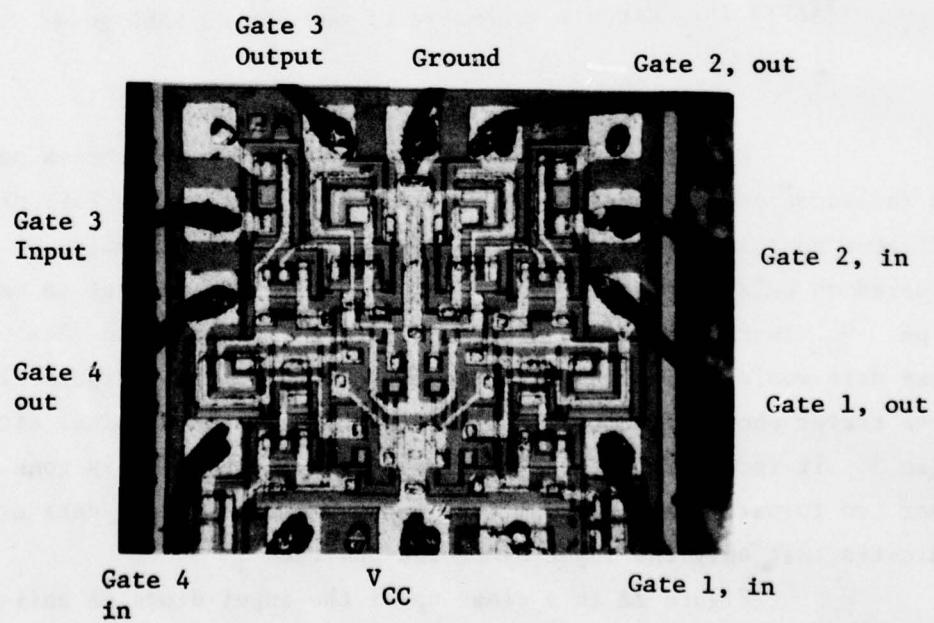
Figure 20. Photomicrograph of 946 HC chip.

Unit 50 was exposed to negative 10- $\mu$ s overstress pulses and failed on pulse 3 at a pulse power of 48.9 watts. The Fairchild 5000 indicated no change in any of the electrical tests up to pulse 3. Failure occurred on pulse 3 when  $I_R$  overranged, indicating a current in excess of 16  $\mu$ A.  $V_{OL}$  increased from a pretest value of .207 volts to .240 volts. These data would indicate a failure of the input diode. Figure 21 is a curve tracer photo of unit 50 for the input to ground terminal after pulse 3. It is clear that the reverse-biased input diode is gone and the other two forward junctions  $Q_1$  (E-B) and  $D_1$  remain. These data also indicates that only the input diode was shorted.

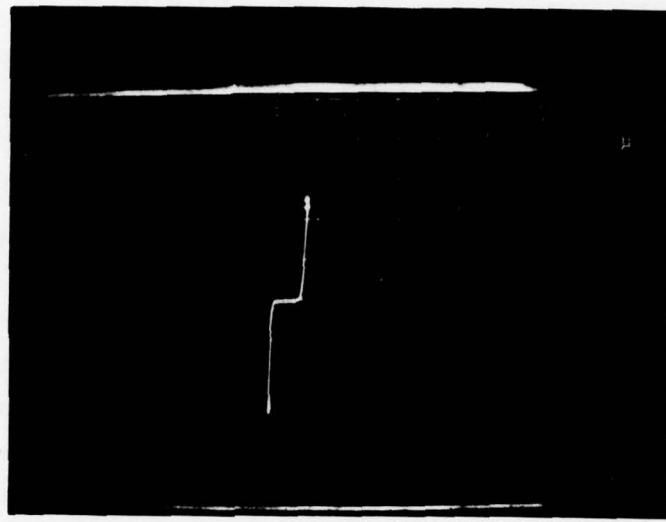
Figure 21. Curve tracer photo of unit 50 after third overstress pulse (input to ground).

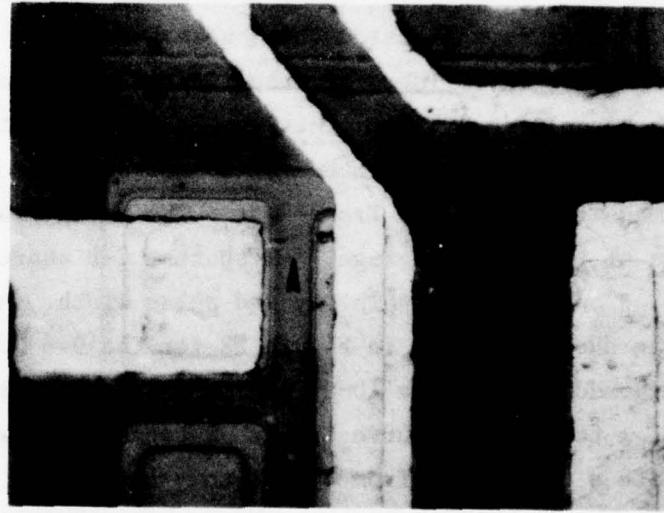
Figure 22 is a close up of the input diode on unit 50 showing the damaged area. The region of damage shown by the arrow is rather small and subtle, a characteristic of junction shorts seen on other devices.

Figure 22. Junction short on input diode, 946 HC unit 50.

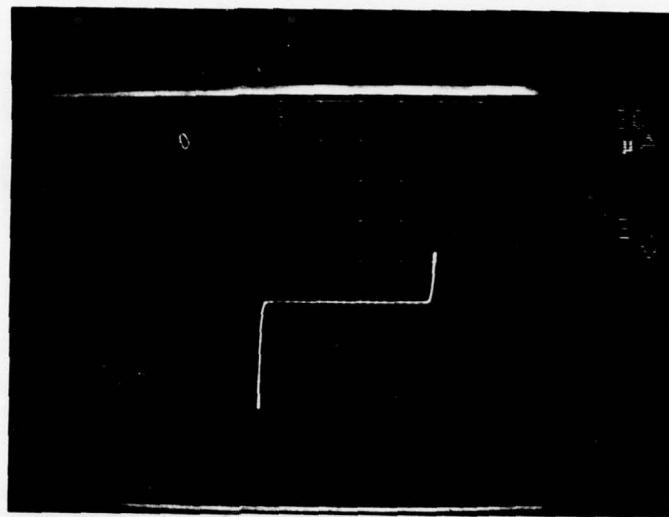
Another type of failure observed on DTL circuits with the inputs stressed was that of multiple junction shorts. This case is illustrated by unit 52, which was subjected to positive 10- $\mu$ s pulses and failed on pulse 6 at a power of 23.9 watts. In this case the Fairchild 5000 data showed an overrange of  $I_R$  plus a failure of  $V_{OH}$ ,  $I_{CEX}$ , a decrease in  $V_{OL}$  and an increase in  $I_{SC}$ . These data would indicate that the input diode was damaged and the output transistor would not assume the high state. In order for the output transistor to go high for the  $V_{OH}$  test the input transistor must be turned off. This cannot be achieved if the emitter-base junction of  $Q_1$  is shorted. The pre- and posttest curve tracer photos shown in Figures 23 and 24 indicate shorts not only at the input diode and the  $Q_1$  (E-B) junction but at  $D_1$  as well. The photomicrographs of Figures 25, 26, and 27 illustrate the junction shorts of junctions  $D_1$ ,  $Q_1$  (E-B) and  $D_2$  respectively on unit 52.

Figure 23. Pretest curve tracer photo of 946 HC unit 52 (input to ground).

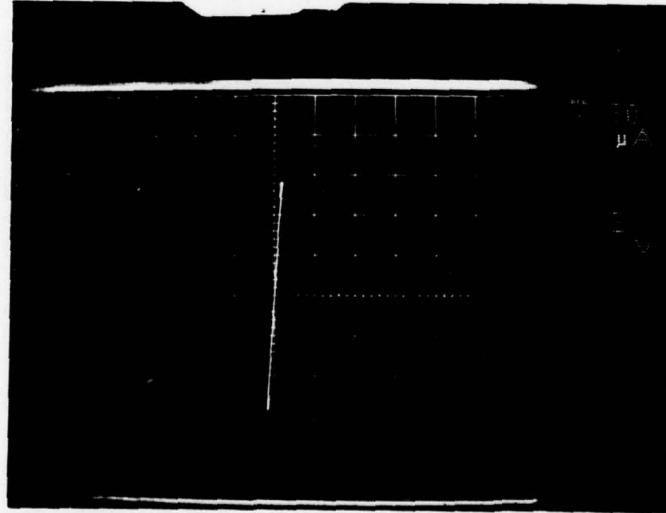
Figure 24. Posttest curve tracer photo of 946 HC unit 52 (input to ground).

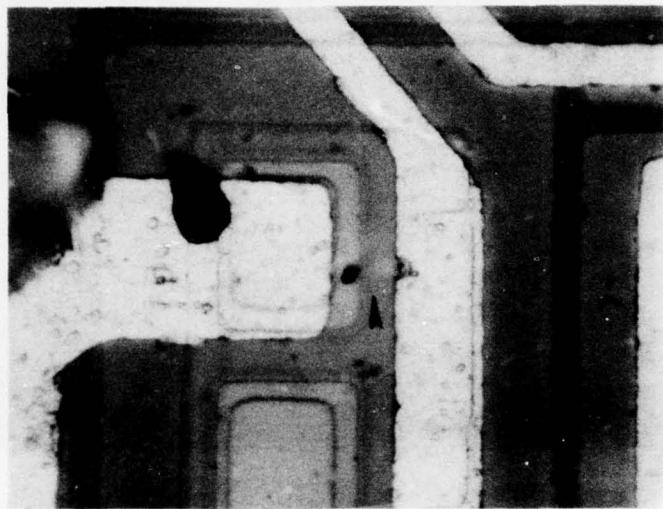
Figure 25. Photomicrograph of  $D_1$  junction short on 946 HC unit 52.

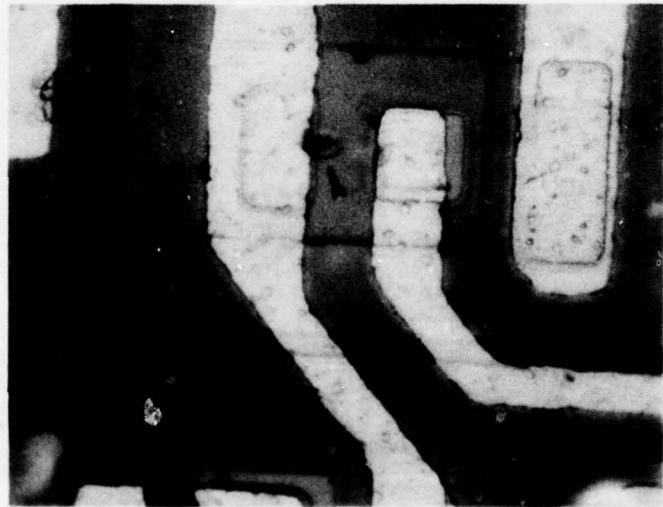
Figure 26. Photomicrograph of Q, (EB) junction short on 946 HC unit 52.

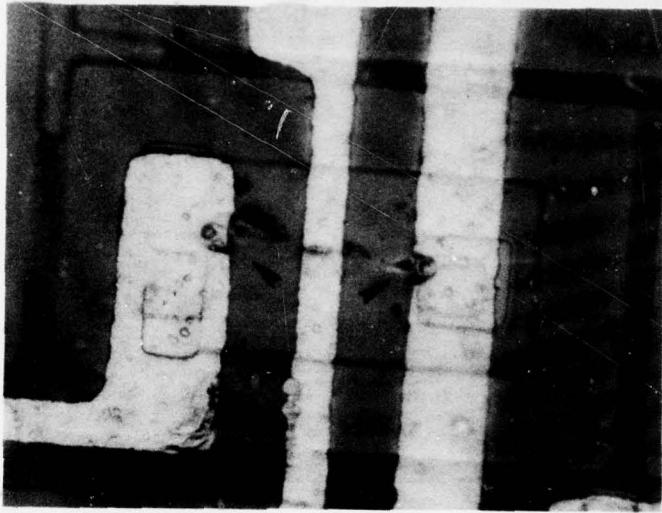
Figure 27. Photomicrograph of  $D_2$  junction short on 946 HC unit 52.

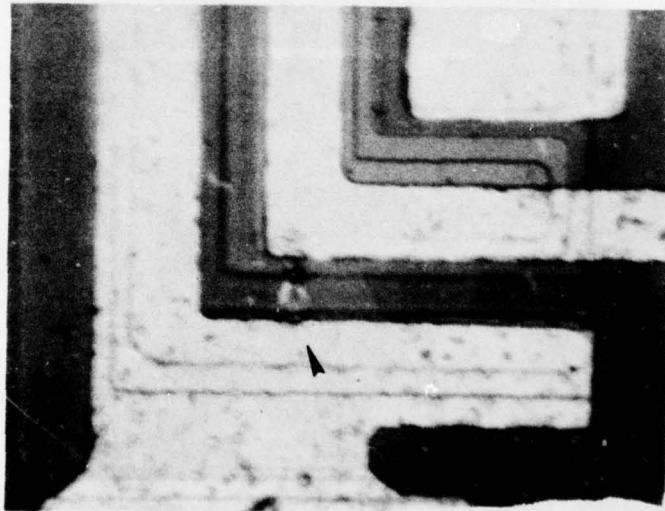
Figure 28. Photomicrograph of output transistor C-E short on 946 HC unit 59.

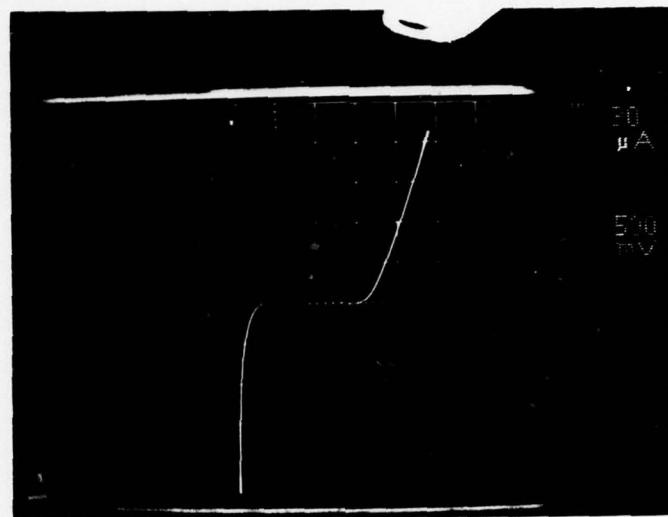
The primary failure mode for output stressed DTL circuits was junction damage to the output transistor. The damage involved all three variations of transistor damage (C-E shorts, C-B shorts, and E-B shorts), depending on the pulse polarity and pulse width. An illustration of a C-E junction short is shown in Figure 28 for the 946 HC unit 59. This unit was exposed to negative 10- $\mu$ s pulses and failed the posttest  $V_{OH}$ ,  $I_{SC}$ , and  $I_{CEX}$  tests. The curve tracer photographs shown in Figures 29 and 30 indicate a dead short from output to ground after the failure pulse.

Figure 29. Curve tracer photo of 946 HC unit 59 pretest.

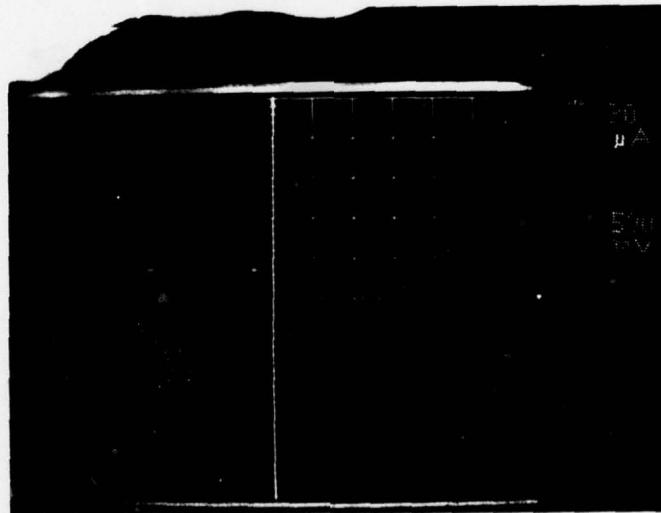
Figure 30. Curve tracer photo of 946 HC unit 59 posttest.

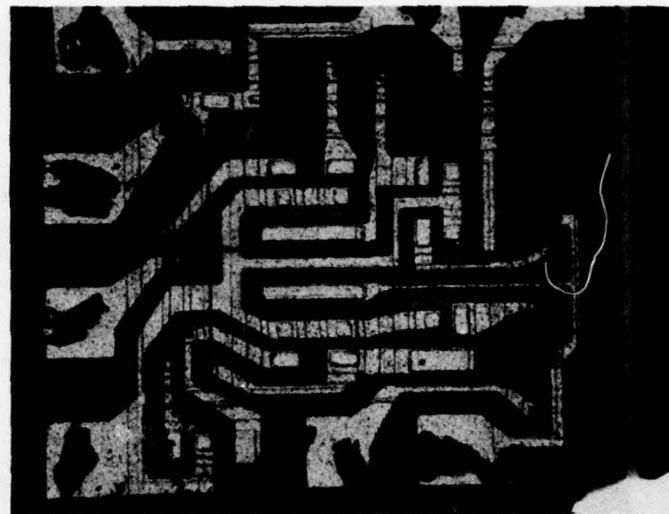
transistor. In some of the RTL circuit layouts, however, the connection to the input pin side of the resistor on one input is in close proximity to the connection to the base side of the resistor on another input. This is illustrated by the photomicrograph of a 908 HC adder circuit shown in Figure 32.

Figure 32. Photomicrograph of 908 HC adder.

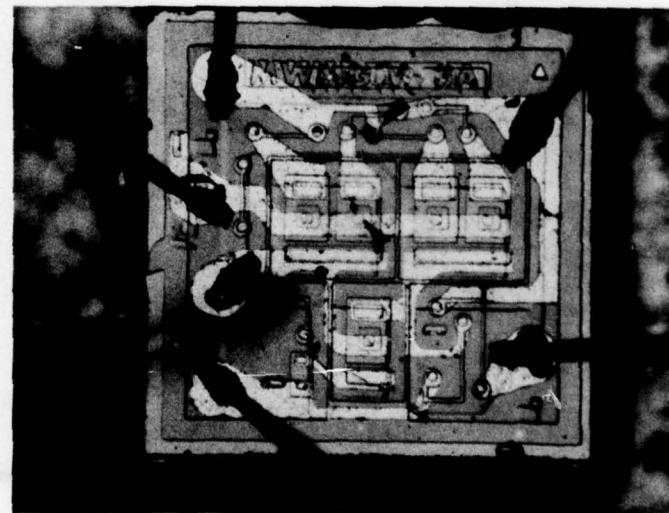
Several devices failed when a short developed from the stressed input to the transistor of an adjacent input, causing a junction short on the adjacent input. This failure mode is shown in Figure 33 for a 908 HC buffer circuit (unit 50) which was stressed on pin 1 with negative 10- $\mu$ s pulses. The initial short is from the stressed input side of the diffused resistor through the isolation to the base side of an adjacent resistor (Figure 34). Once this path was established, the emitter base junction of the adjacent transistor was shorted (Figure 35). The same failure mode was also observed on the 908 HC for positive overstress pulses. The only other failure mode for the input stressed condition was a substantial drop in the input resistor value, observable on the curve tracer photos. This drop was generally observed before the actual failure pulse but probably contributed to failure of the input transistor by lowering the resistive path to the input transistor.

Figure 33. Photomicrograph of 908 HC buffer chip unit 50.

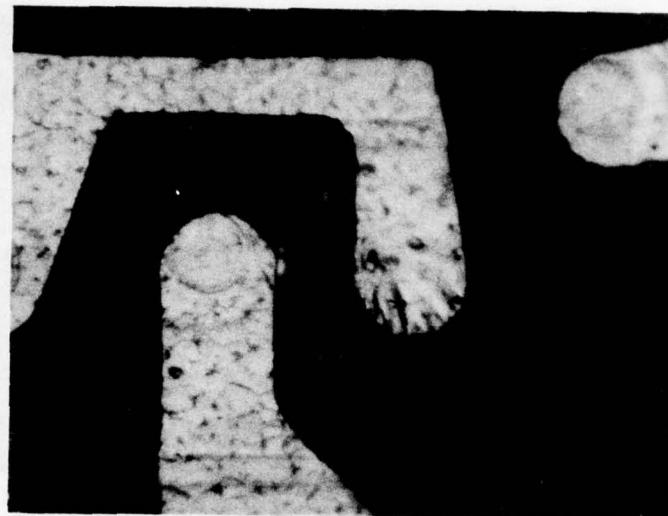
Figure 34. Photomicrograph of resistor-resistor short on 908 HC unit 50.

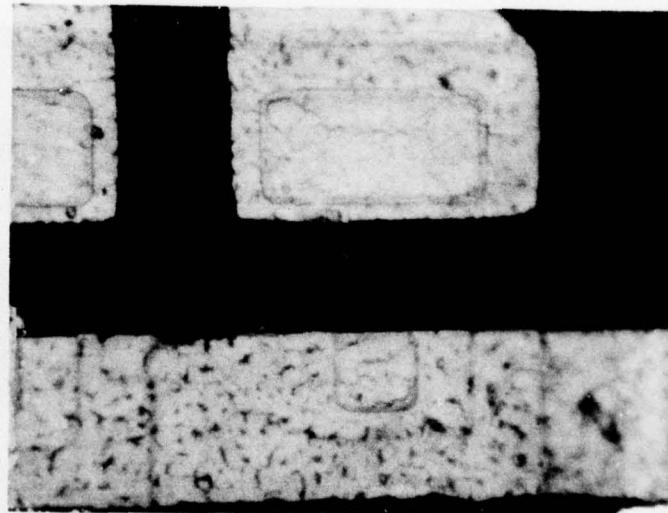
Figure 35. Photomicrograph of emitter base short on 908 HC unit 50.

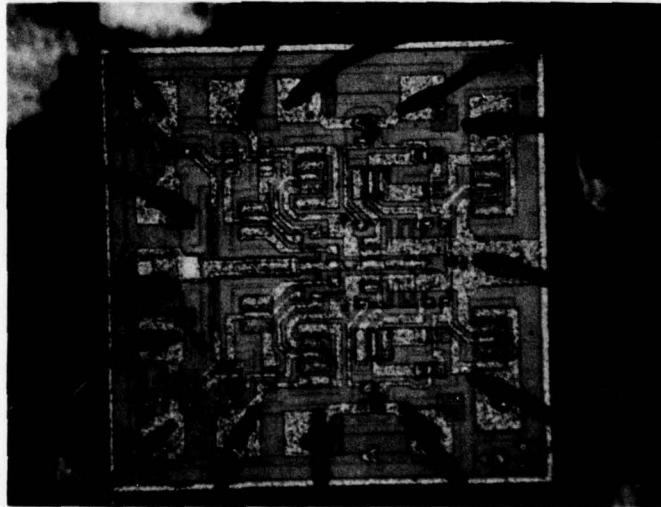
Figure 36. Photomicrograph of N7400F unit 7, illustrating clamp short.

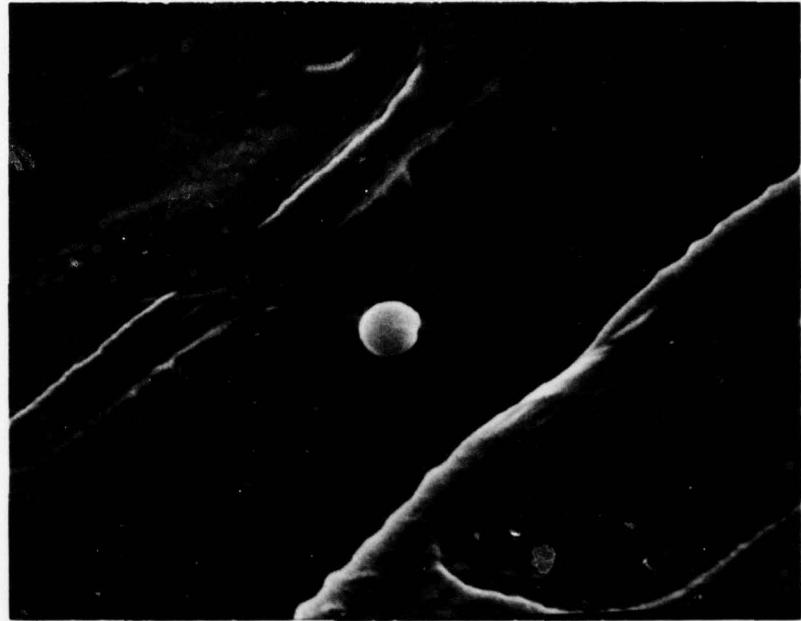
Figure 37. SEM picture of diode junction short on N5710T.

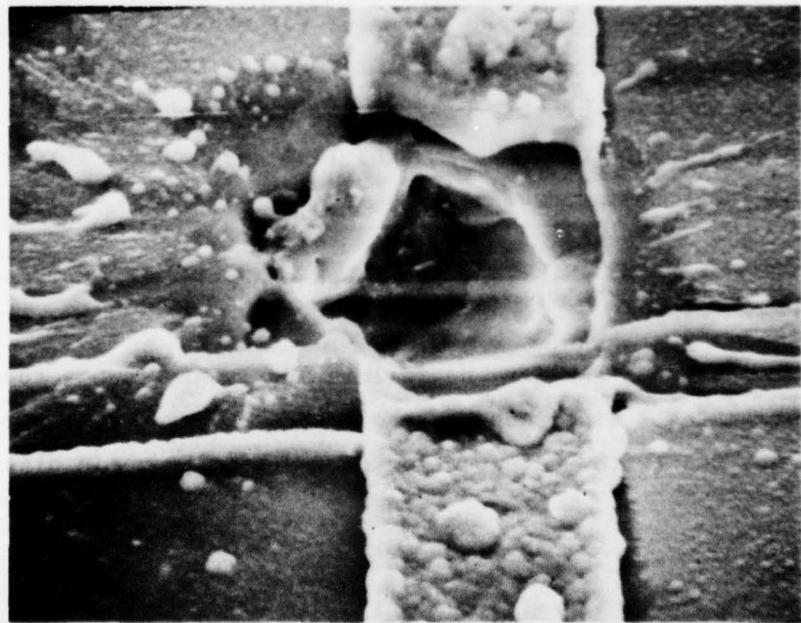
Figure 38. SEM picture of metallization burnout on a  $\mu$ A747.

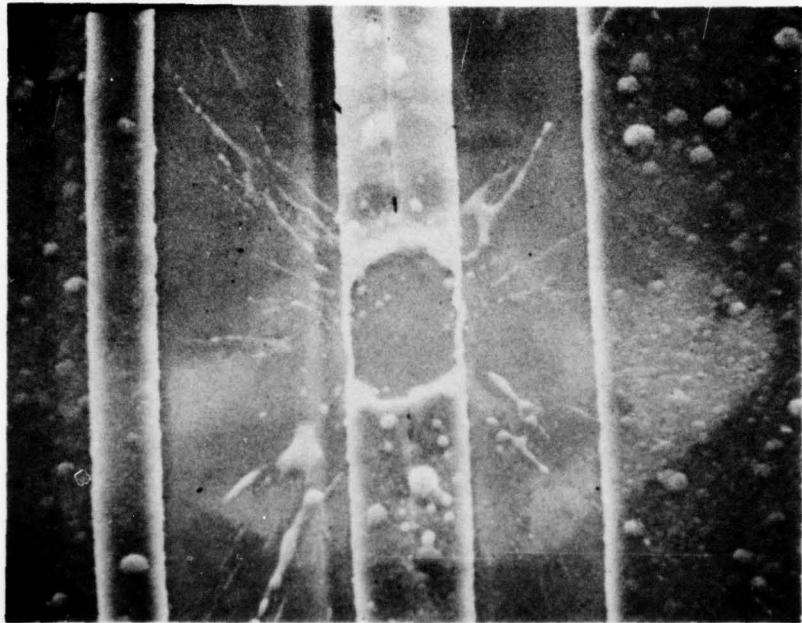
Figure 39. SEM picture of metallization burnout on an LM111.

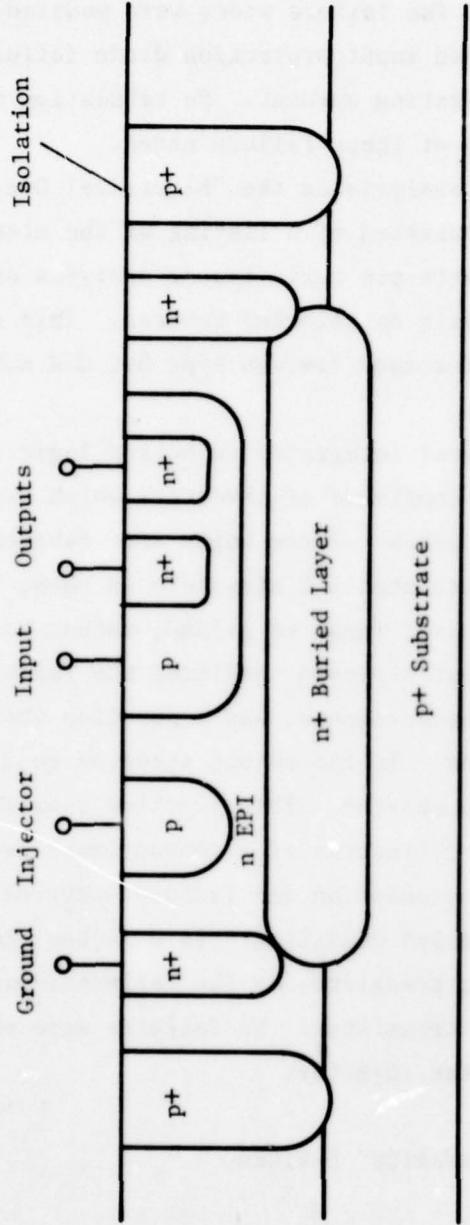
In this program several integrated injection logic ( $I^2L$ ) devices were tested. The  $I^2L$  devices consisted of inverters which were bonded out from a large array of  $I^2L$  gates. These units were fabricated using a conventional double diffused isolated  $I^2L$  structure as shown in Figure 40. The  $I^2L$  inverters were pulsed input to ground, output to ground, and injector to input. In the input stressed condition the failure mode, as determined from curve tracer measurements, was a junction short across the input-to-n epitaxial region. In the output stressed condition, the output collector base junction shorted. This junction consists of what would be the emitter and base diffusions of a conventional device. For the injector-to-input stressed condition the failure occurred at the same junction as for the input stressed condition. This is the emitter base junction of the vertical n-p-n transistor or the collector-base junction of the lateral p-n-p injector transistor. No failures were observed for the emitter-base junction of the injector.

Figure 40.  $I^2L$  inverter.

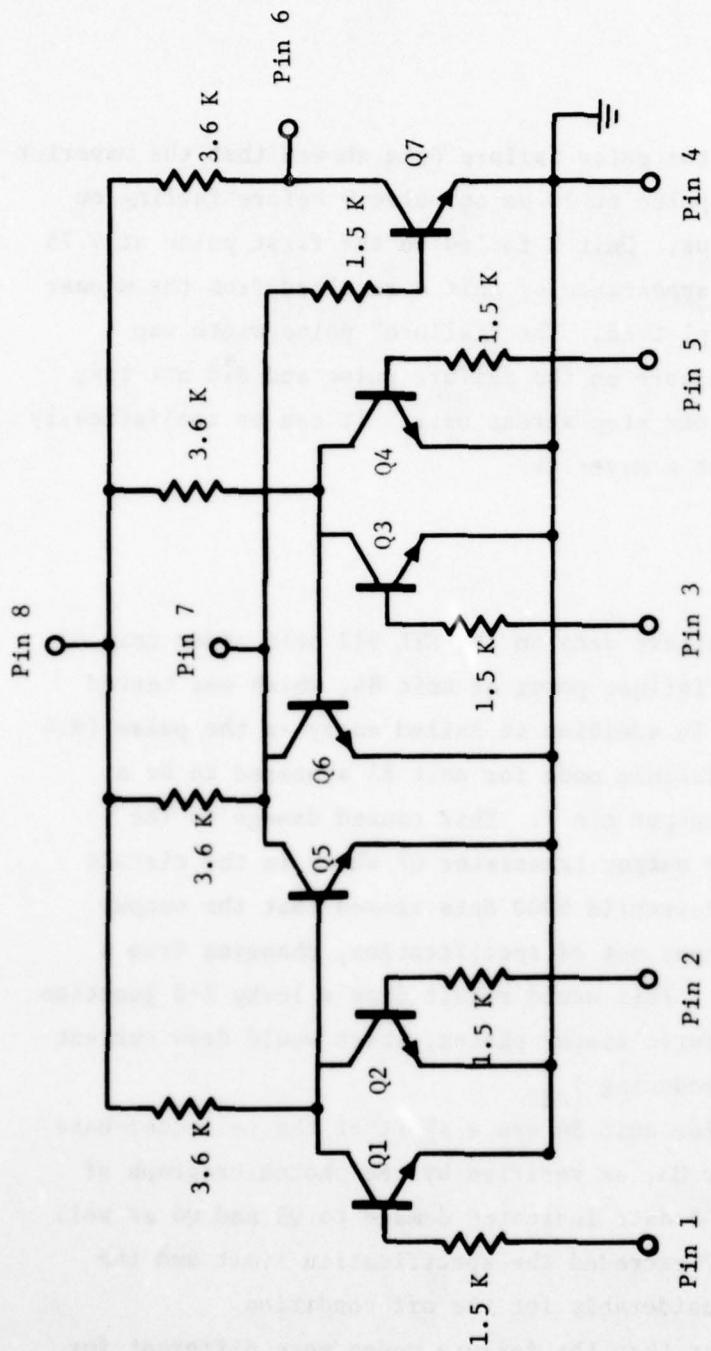
The pulse power failure data on the RTL 912 half adder unit 83 was a factor of 3 below the failure power of unit 84, which was tested under the same conditions. In addition it failed early in the pulse (0.4  $\mu$ s for a 1- $\mu$ s pulse). The failure mode for unit 83 appeared to be a short from the  $V_{CC}$  line to output pin 7. This caused damage to the emitter-base junction of the output transistor Q7 shown in the circuit diagram of Figure 41. The Fairchild 5000 data showed that the output current high (test  $I_{A3}$ ) dropped out of specification, changing from a value of -.47 mA to -.30 mA. This would result from a leaky E-B junction on Q7, as indicated by the curve tracer photos, which would draw current from the pin 7 output thus reducing  $I_{A3}$ .

The failure mode for unit 84 was a short of the collector-base junction of input transistor Q3, as verified by the photomicrograph of the chip. The Fairchild 5000 data indicated damage to Q5 and Q6 as well since the  $V_{SAT}$  test at pin 7 exceeded the specification limit and the current at pin 7 went up considerably for the off condition.

Figure 41. Circuit diagram of 912 HC.

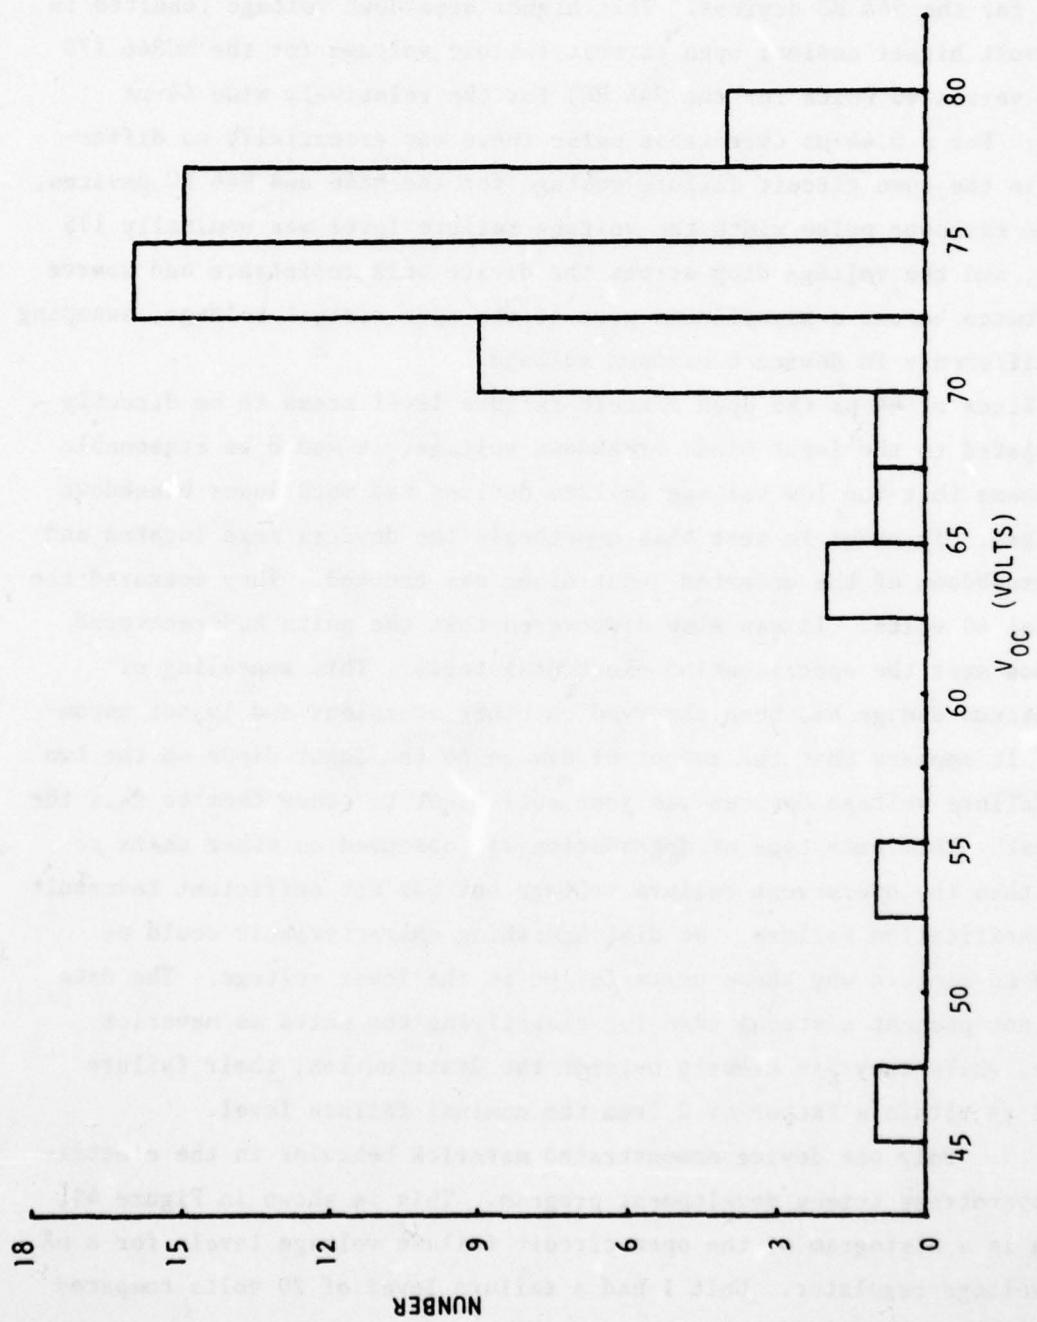
Only two device types (one from each program) met the criterion. The MC846, tested on the E-4 program and reported in reference 17, had two units which had an open failure voltage well below the mean for the 44- $\mu$ s input test condition. The histogram for the distribution which totaled 50 samples is given in Figure 42. The failure mode for the two low voltage failures was the same as for the other devices, a junction short on the input diode.

Figure 42. MC846 Input failure voltage histogram, 44- $\mu$ sec pulse.

As discussed in reference 17, the breakdown voltage for the input diode of the MC846 devices was nominally 40 volts compared to 10 volts for the 946 HC devices. This higher breakdown voltage resulted in a 30-volt higher nominal open circuit failure voltage for the MC846 (70 volts versus 40 volts for the 946 HC) for the relatively wide 44- $\mu$ s pulse. For a 0.44- $\mu$ s overstress pulse there was essentially no difference in the open circuit failure voltage for the M846 and 946 HC devices. At the narrower pulse width the voltage failure level was nominally 175 volts, and the voltage drop across the device bulk resistance and source resistance became a significant part of the open circuit voltage, swamping the difference in device breakdown voltage.
